COASTAL GEOMORPHOLOGY OF THE NORTHERN  
CANTERBURY COASTLINE

# 11<sup>TH</sup> IAG INTERNATIONAL CONFERENCE ON GEOMORPHOLOGY

# Coastal Geomorphology of the Northern Canterbury Coastline

## Field guide for the International Conference on Geomorphology mid-conference field trip

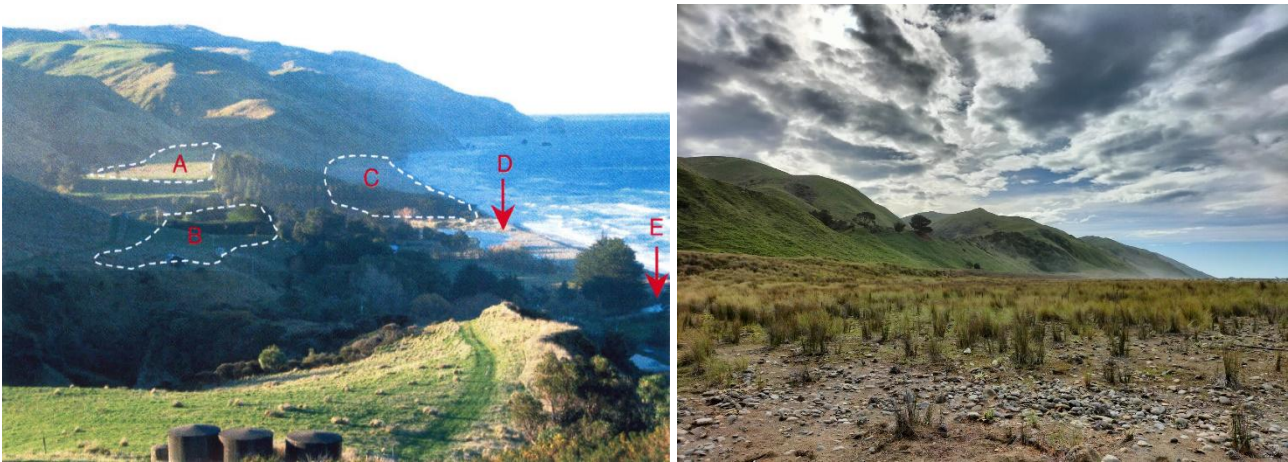
**Figure 7.** (Left) Looking north along Gore Bay with geomorphic features annotated. Dashed lines border areas of: (A-B) raised terraces and (C) northern coastal plain with relict sand dunes. Arrows point to the (D) Jed River, and (E) Buxton Stream mouths (Vessey, 2003). (Right) Marine terraces and relict sand dunes (location C in previous photo). The beach is to the right hand side of the photo.

The geology of Gore Bay is shown in Figure 6 (below). Figure 7 shows a photo looking down on the bay, with landform units identified, and an image of the backshore morphology north of Jed River.

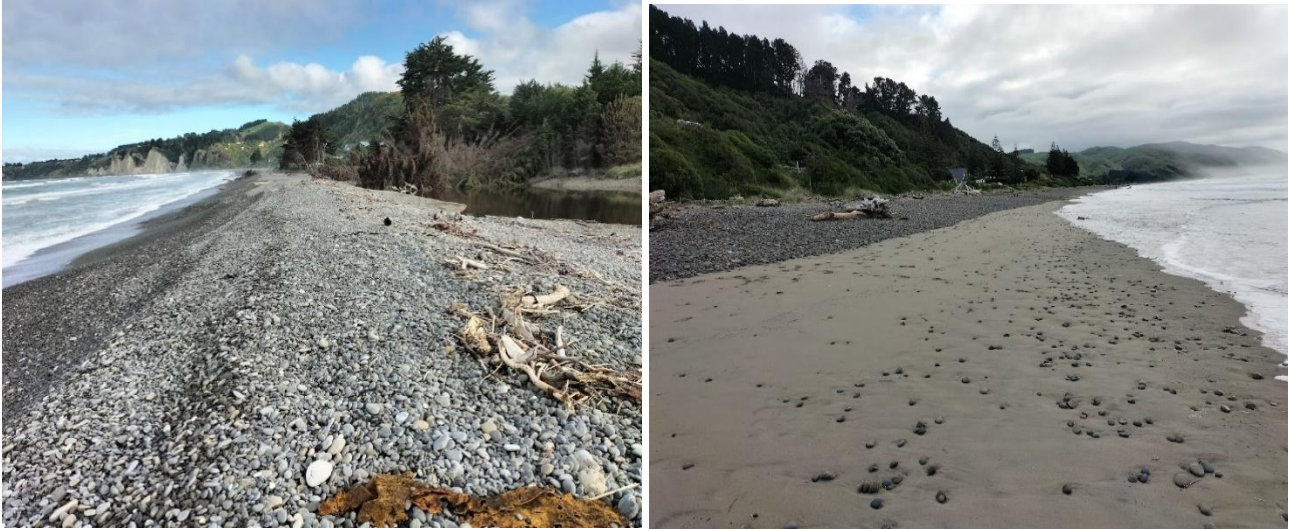
**Figure 9.** (Left) North Gore Bay (approximately 100 m north of where we parked for Stop 1) looking south. Jed/Buxton Lagoon is visible on the landward side of the image. (Right) South Gore Bay looking north (Stop 2) where the beach morphology shows a distinct split between sand and gravel.

The beach morphology of Gore Bay varies alongshore and can switch between composite and MSG beach states. This has resulted in Gore Bay being referred to as a “transitional” MSG beach (Vessey, 2003; Jacobs, 2020) (Figure 9). Along Gore Bay, the distribution of sand and gravel varies both spatially and temporally, as does the beach morphology. Coarser sediment is generally concentrated in the north, where the beach is also steeper (Vessey, 2003). To the south, the beach morphology typically displays a lower-gradient, sandy foreshore with distinct boundary between gravels on the upper foreshore and towards the backshore – more akin to a composite beach morphology. The generalised differences in MSG and composite beach morphology are shown in Figure 10.

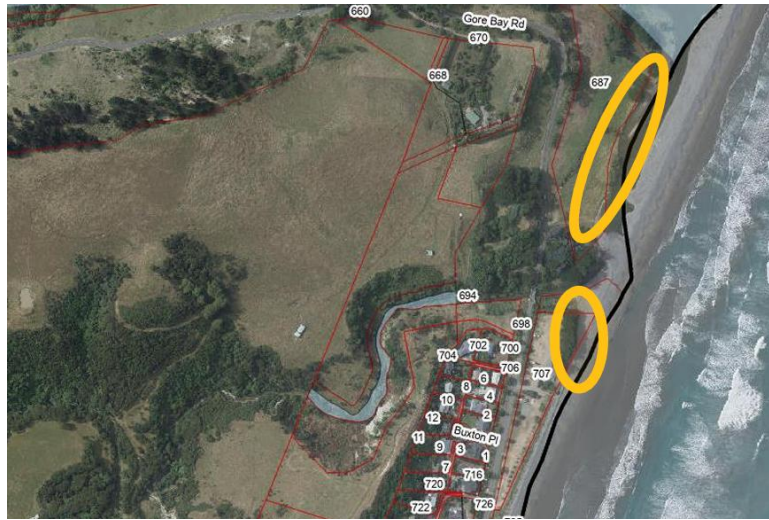
**Figure 12.** Hotspots of coastal erosion adjacent to the river mouths (Hurunui District Council, 2023).

In the last 40 years, 15-20m of land at the seaward side of the **Jed-Buxton Foreshore Reserve** has eroded (Jacobs, 2020; Hurunui District Council, 2023) (Figure 12). The erosion is caused by the combined presence of floodwater and large seas. Big seas are likely to cause erosion in two ways:

1. When the combined river mouth is **open** water enters the river mouth and hits the bank behind the lagoon directly.
2. When the combined river mouth is **closed** water overtops the gravel bar flowing across the backed-up water hitting the bank behind the lagoon.

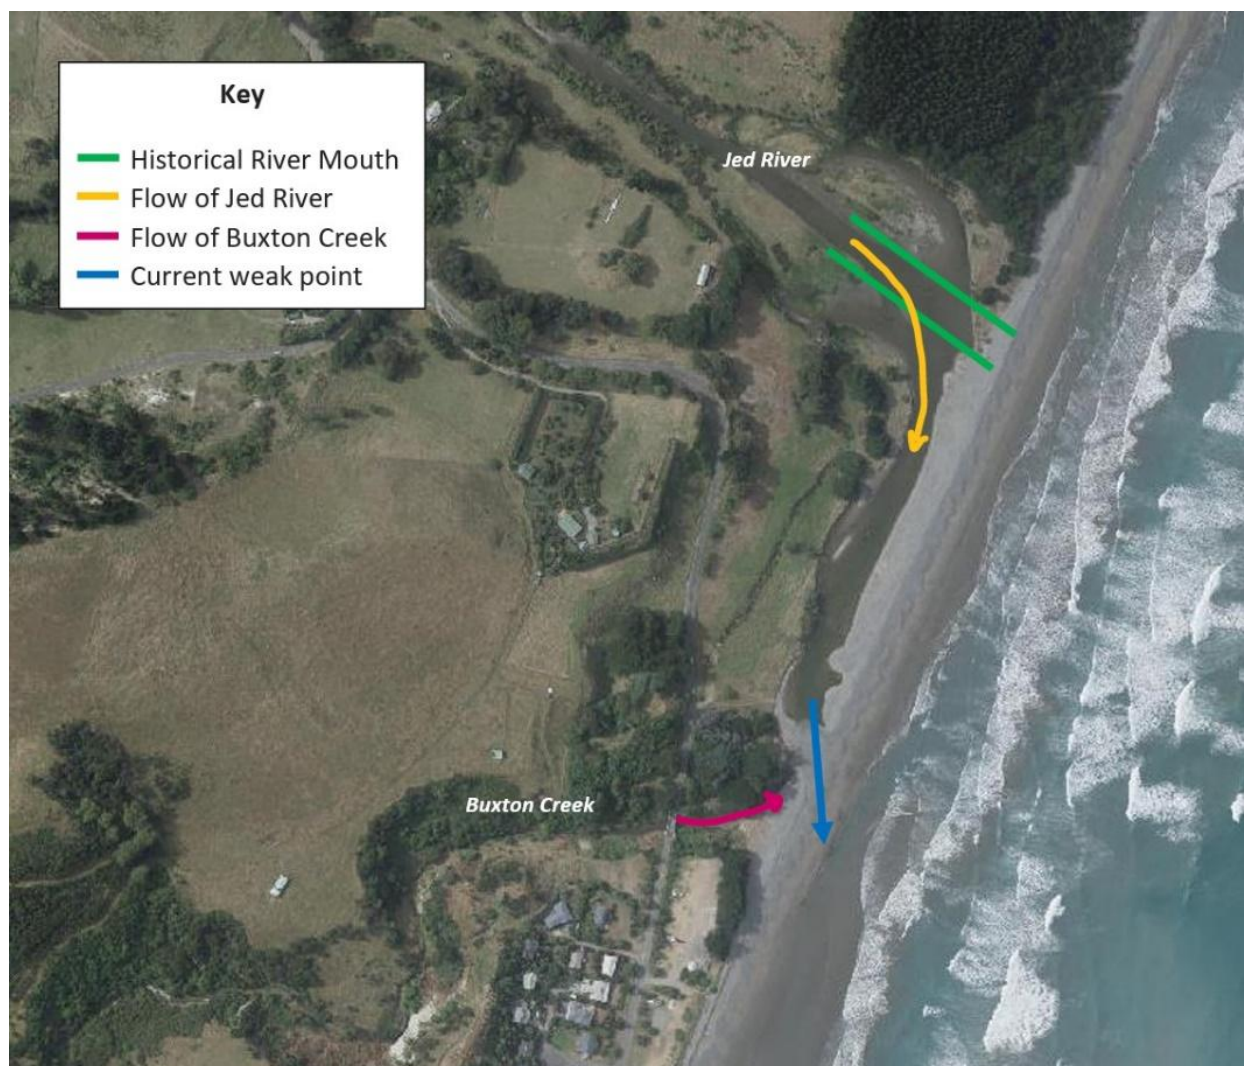
**Figure 14.** Jed River and Buxton River flow paths and river mouths (Hurunui District Council, 2023).

**Decadal scale change:** Over the past 40 years, migration of the Jed River outlet channel has resulted in two rivers now flowing into a single lagoon and discharging through a common mouth across a gravel beach barrier (Figure 14). These changes have triggered erosion and inundation issues which are affecting nearby land and critical infrastructure.

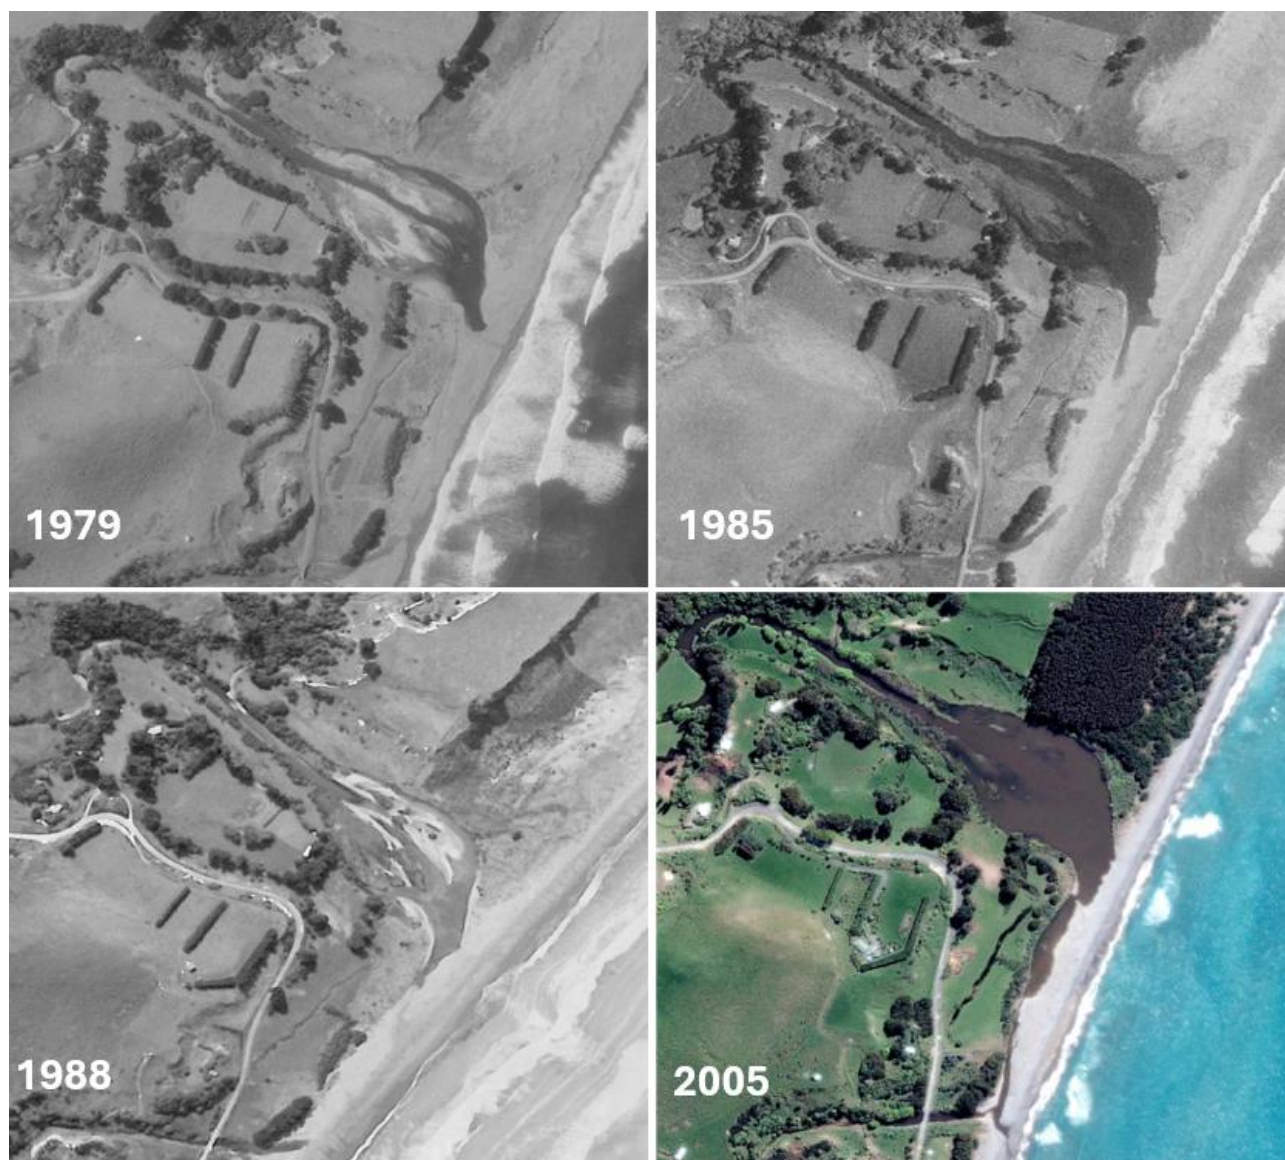
**Figure 15.** Migration of the Jed River outlet channel viewed in aerial imagery (Somerville, 2023).

An analysis of decadal scale dynamics using shoreline mapping and storm identification distinguished a period of high storm frequency, low rainfall and shoreline erosion from 1985 to 1988 (Somerville, 2023). These conditions align with the first signs of outlet migration visible in aerial imagery (Figure 15).

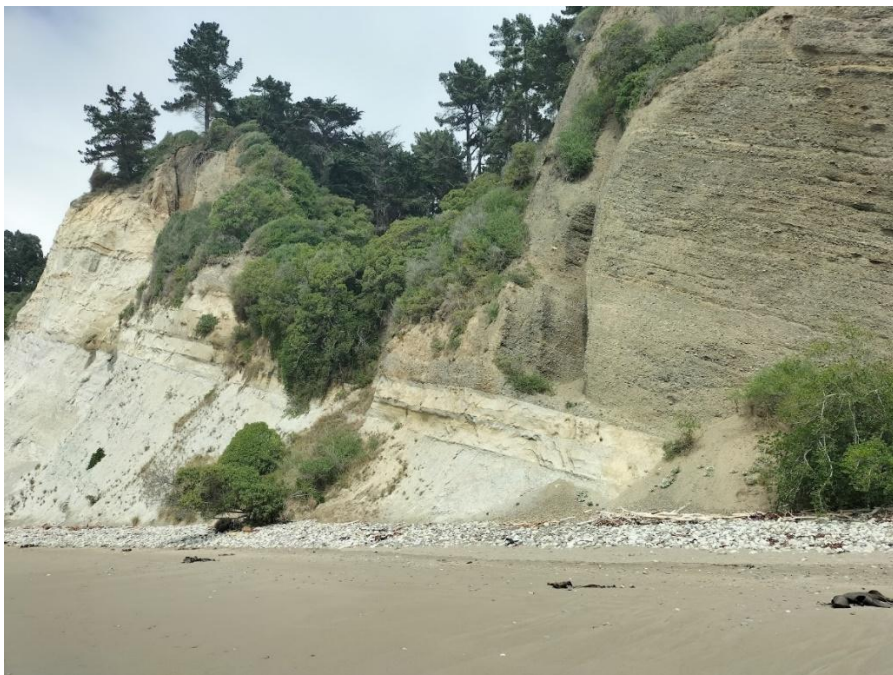
**Figure 26.** Exposure of the coastal cliffs at South Gore Bay. Photo: S. McSweeney

The cliffs at the southern end of Gore Bay expose a cross-section through shallow to deep water calcium carbonate-rich ocean sediments. The Oligocene-aged Motunau Group here consists of limestone, extensive calcareous (calcium carbonate-rich) mudstone, and with greensand at the base (Figure 26). The first unit is the shallow ocean debris-flow conglomerates in the Greta Formation, which are also seen at Cathedral Cliffs. Directly beneath the conglomerates lie the mudstones and fine limestone beds of the Motunau Group. In time, these deposits all record the ocean depth decreasing as the New Zealand landmass was lifted out of the water over the last 25 million years. The greensand is green in colour because it contains high quantities of the mineral glauconite. Glauconite is an interesting potassium-rich mineral that forms in marine sediments and can be influenced by the decaying process of organic matter with high biological activity. It is therefore most commonly found in continental shelf environments with low sedimentation rates.

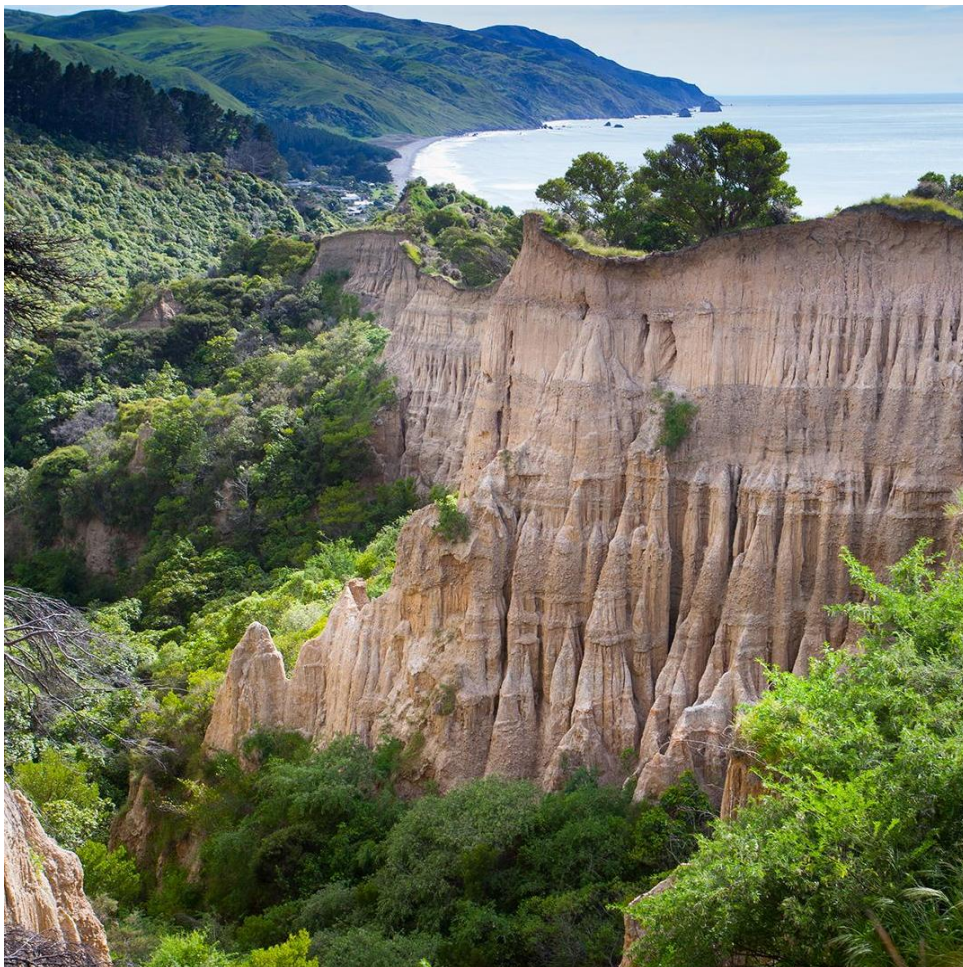
**Figure 27.** The Cathedral Cliffs viewpoint which overlooks an impressive series of rock pillars formed by rainwater erosion of the soft rock. Photo: K Pedley. (<https://www.geotrips.org.nz/>).

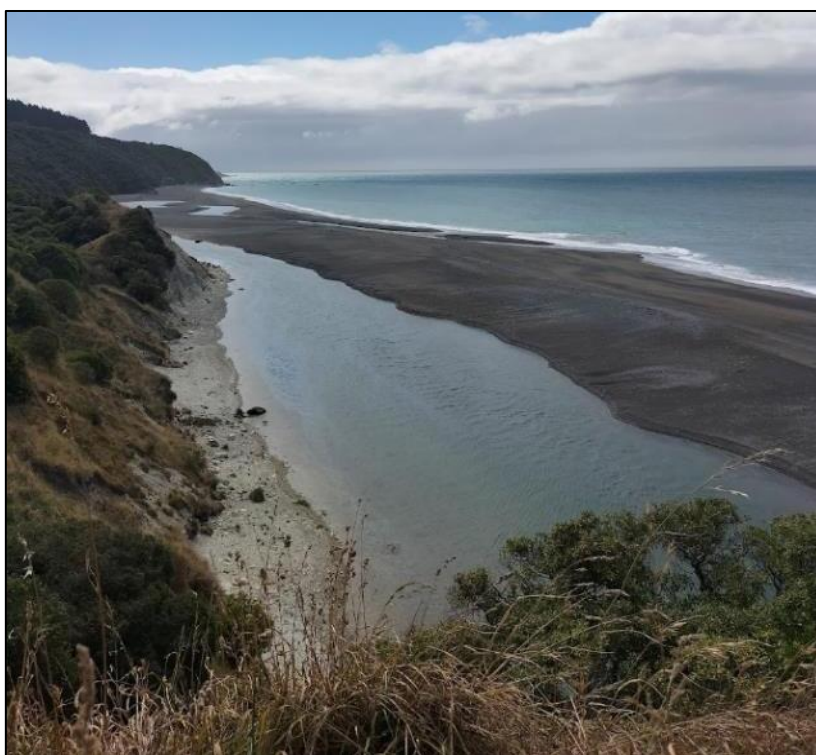
**Figure 28.** Hurunui hapua looking towards the north. Photo: S. McSweeney.

Hāpua are river-mouth lagoons on New Zealand's high-energy mixed sand–gravel coasts. They differ from estuaries because there may be negligible tidal exchange (especially when presenting as intermittently closed estuaries) and are dominated by the interaction of river discharge, wave energy, and sediment transport behind coarse-grained barriers. The Hurunui hāpua is a shore-parallel lagoon impounded behind a mixed sand–gravel barrier and constrained landward by Amuri Limestone cliffs (Figure 28).

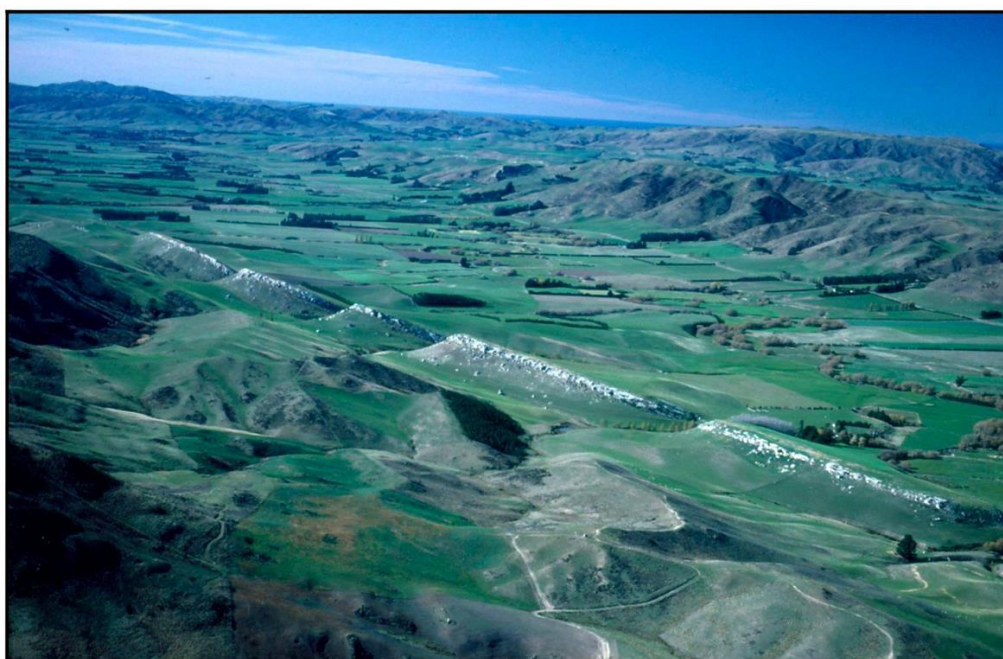
**Figure 33.** Oblique aerial view looking to the south-east across north-east trending valleys and hills indicating synclines and anticlines. In the foreground Weka Pass and Amuri limestones form cuestas inclined toward the centre of the Scargill Valley (Tonkin et al., 2015).

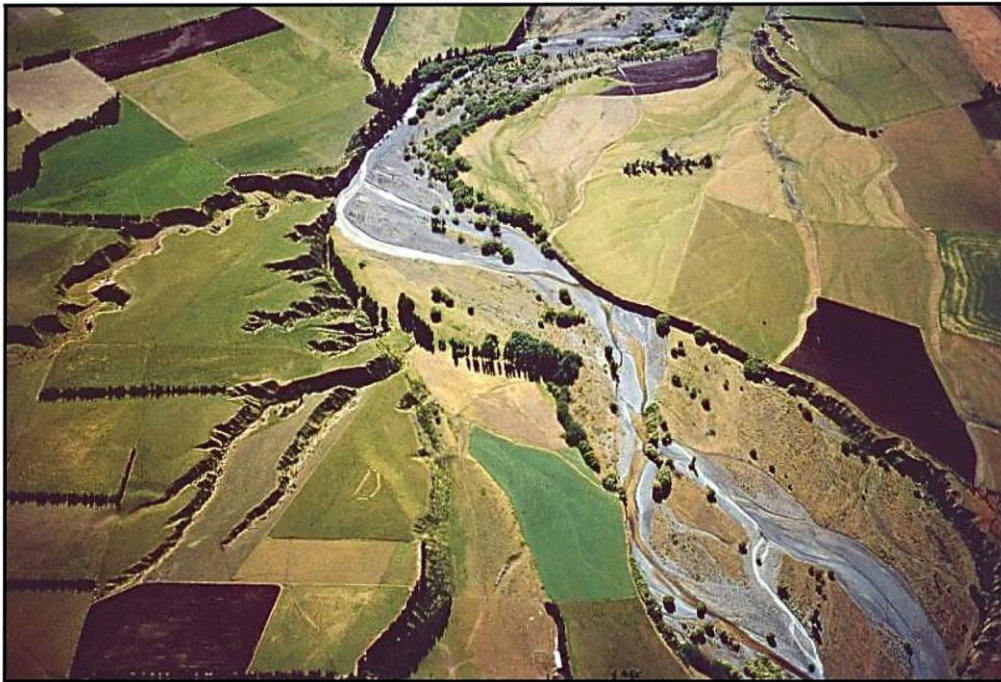
**Figure 34.** Waipara River with gullies eroded into older fans (left) and terraces incised below the Canterbury Surface (right) (Tonkin et al., 2015).

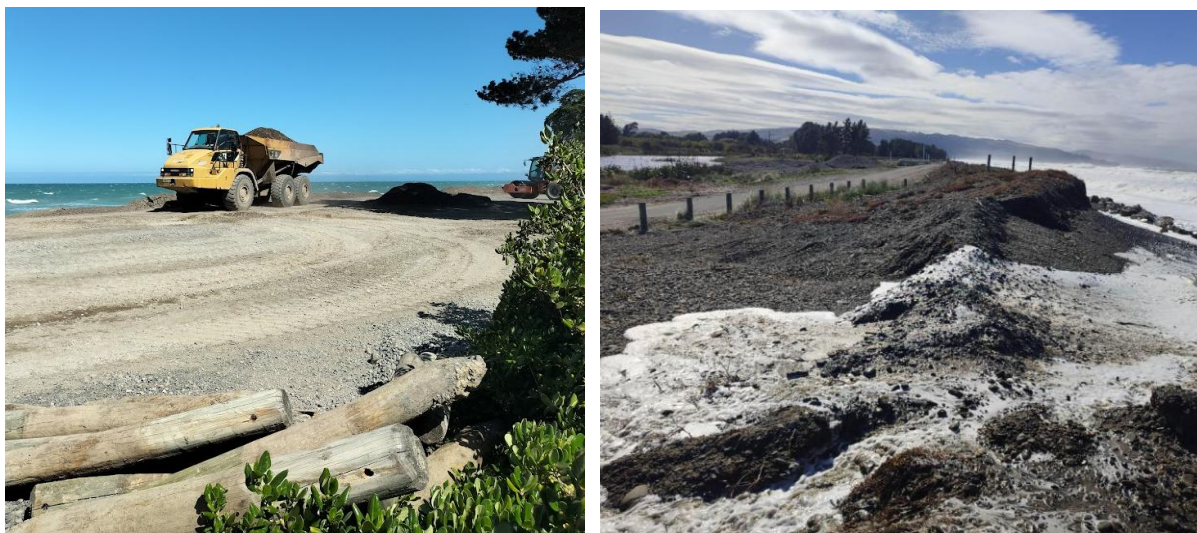
**Figure 36.** (Left) Bund reconstruction at Amberley Beach and (right) water washing over bund. Images from: S. McSweeney and Hurunui District Council (2023).

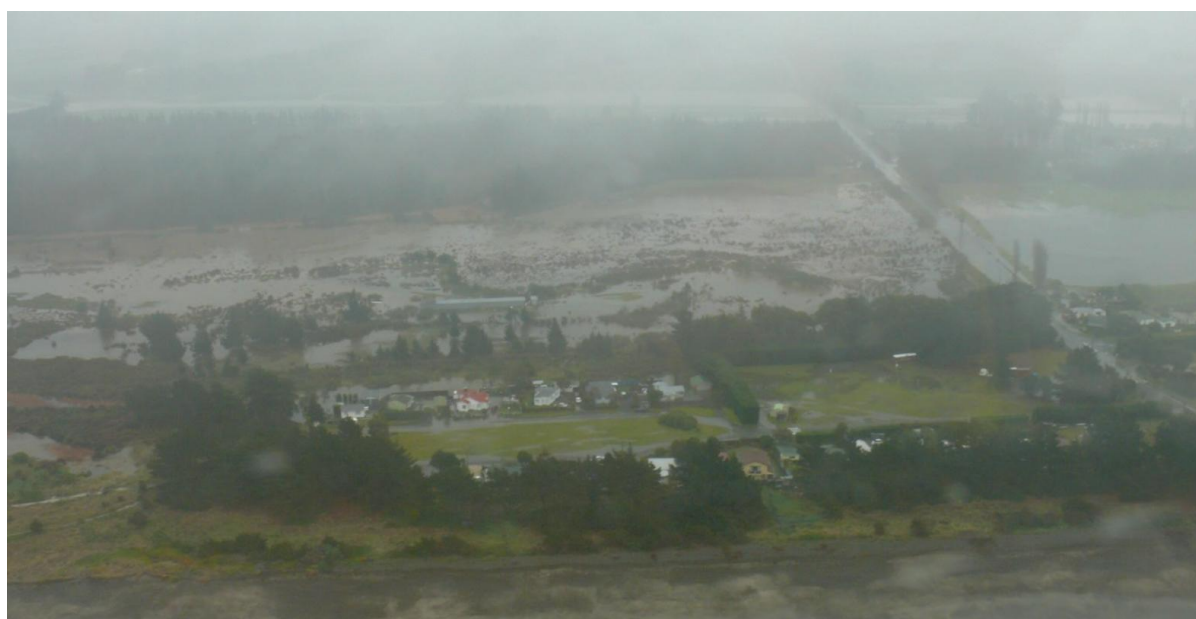
**Figure 37.** Inundation event at Amberley Beach showing ponding of water on low-lying land and lagoons image from Hurunui District Council (2023b).

In addition to erosion, the settlement is exposed to flood and inundation hazards (Figure 37). To the south and north of the town, there are two coastal lagoons - Mimimoto Lagoon (south) and Amberley Beach Lagoon (north). Neither of these lagoons have a permanent opening to the sea, with their outlet channels normally blocked by beach sediment. This prevents the regress of high lagoon water levels but allows the ingress of sea water during coastal storm events, both which add to the flood hazard. Rising groundwater and fluvial and pluvial flooding add to the inundation risk.

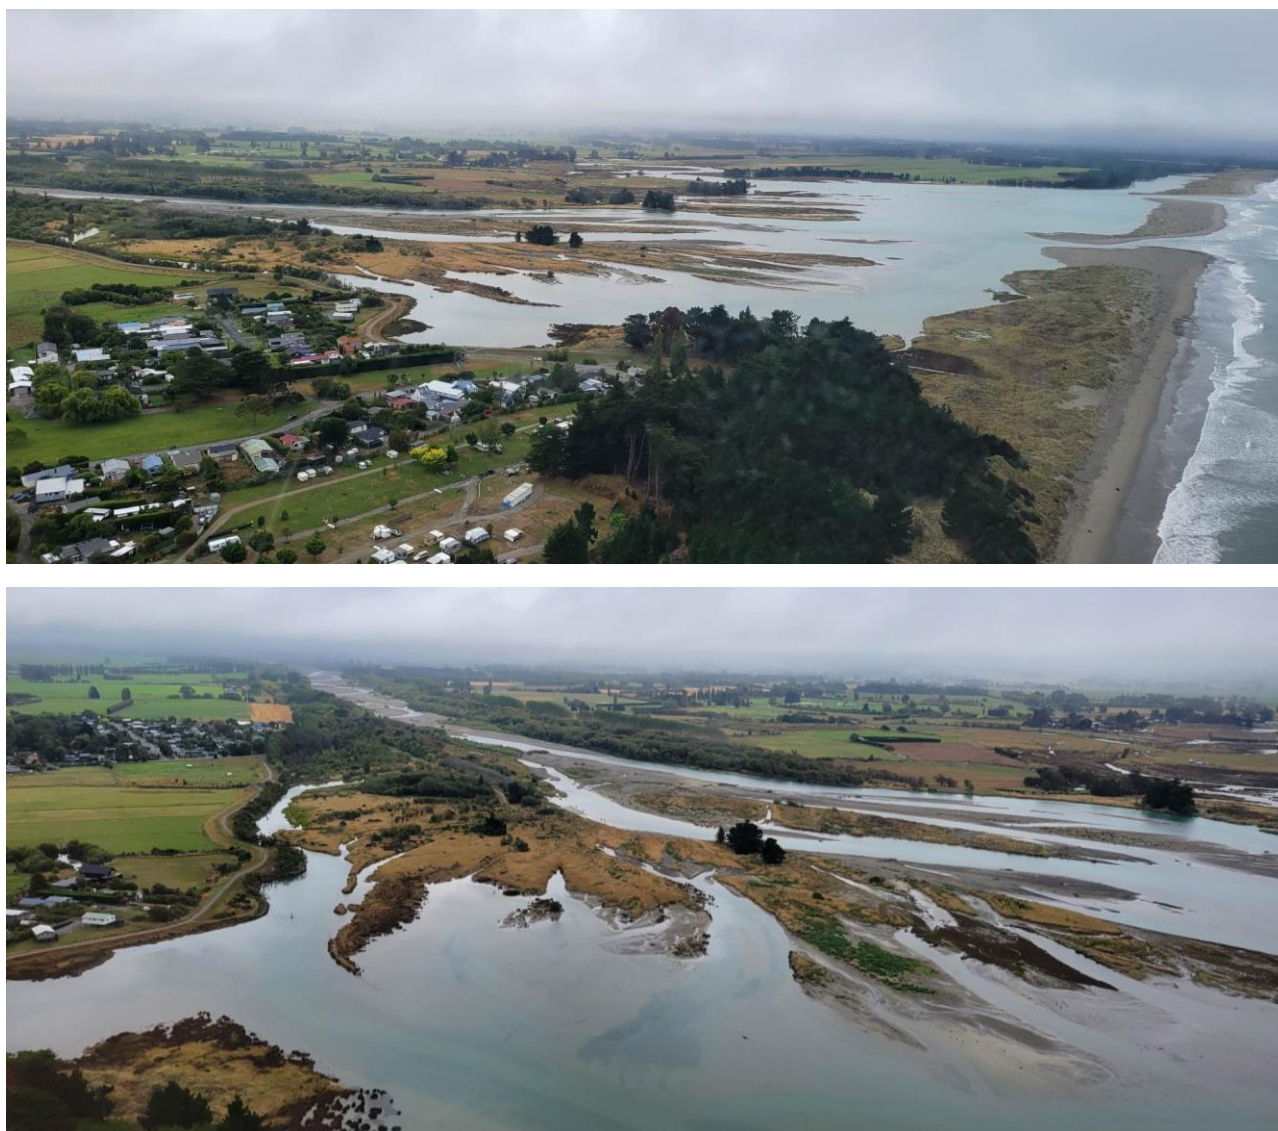
**Figure 40.** Images showing the barrier and estuary morphology and delta prograding into the Ashley-Rakahuri lagoon. Photos: S. McSweeney.
