# FIELDTRIP GUIDE

ENGINEERING GEOMORPHOLOGY AND ALPINE  
HAZARDS AROUND ARTHUR'S PASS, SOUTHERN  
ALPS

2–6 February 2026

## Mid-conference fieldtrip: Engineering geomorphology and alpine hazards around Arthur's Pass, Southern Alps.

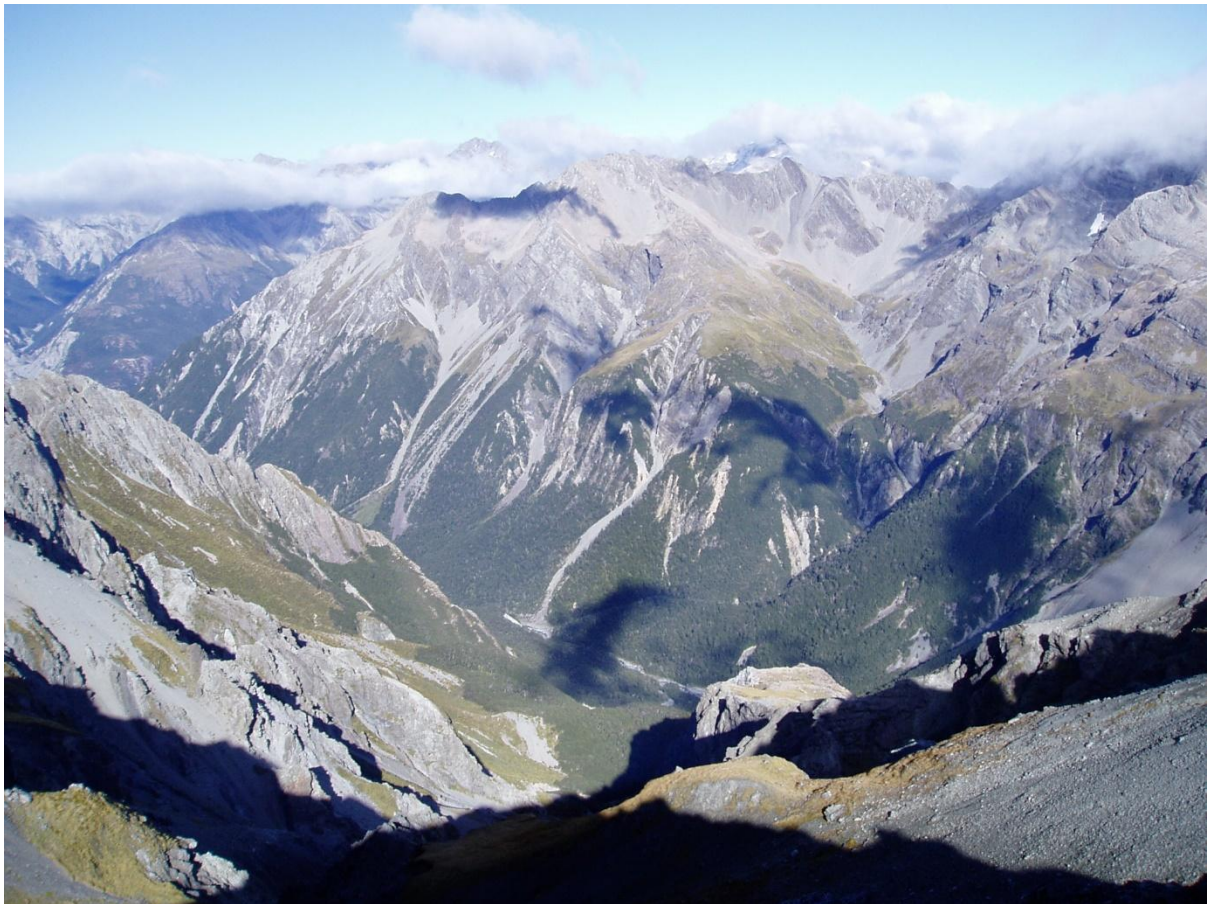
*View of mountains west of Arthur's Pass, showing steep alpine slopes and evidence of active erosion processes typical of the area.*

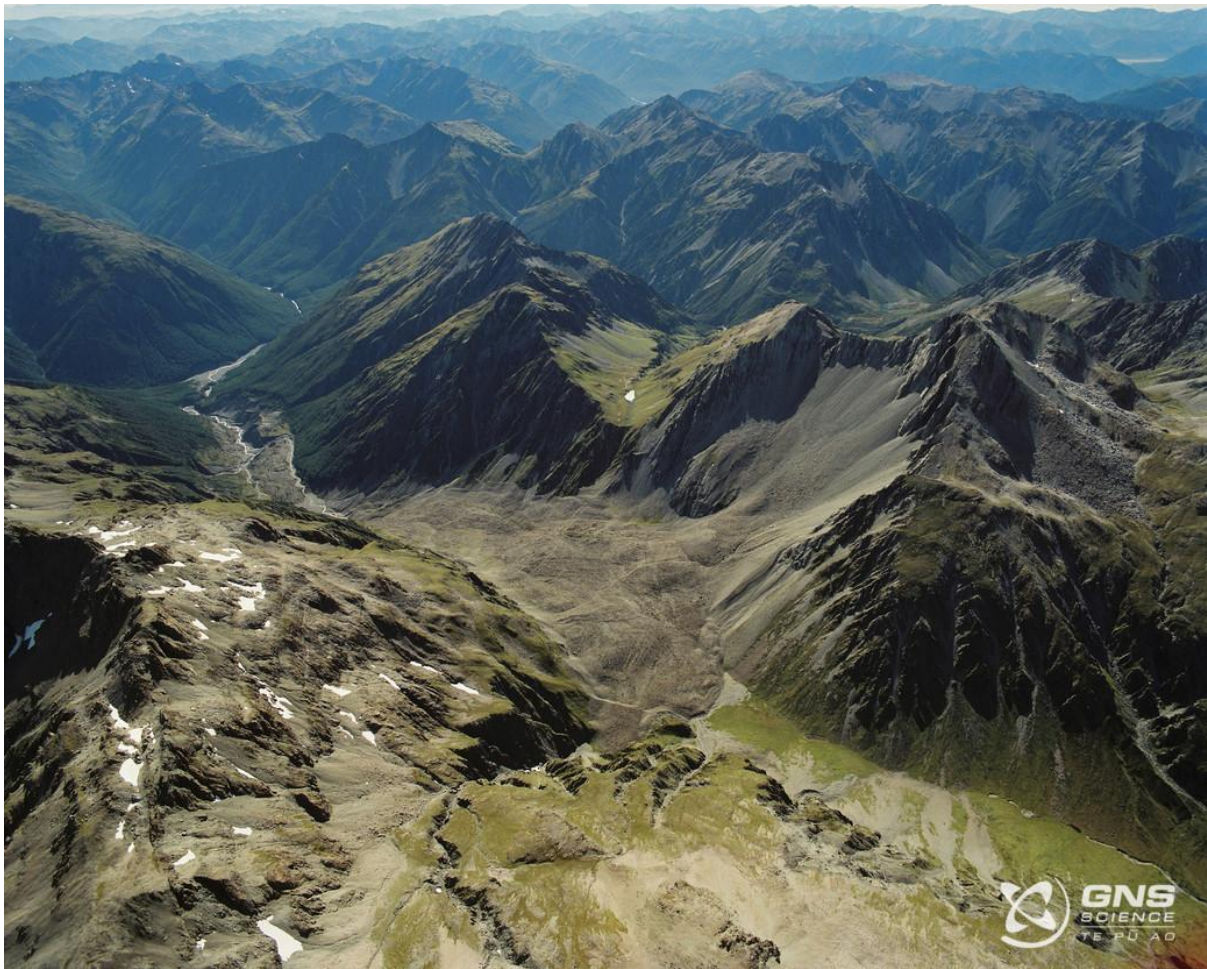
*Figure 2: Falling Mountain Rock Avalanche, triggered during the 1929 Arthur's Pass Earthquake. The rock avalanche is some 10 km northeast of Arthur's Pass village. Photo: LD Homer.*

The faults also contribute to the high seismic hazard of the area, and major historical earthquakes include the 1929  $M_w$  7.0 and 1994  $M_w$  6.7 Arthur's Pass earthquakes. These earthquakes triggered widespread landslides, including the ~60 million cubic metre Falling Mountain Rock Avalanche triggered in the 1929 earthquake (Figure 2). The rock avalanche occurred some 10 km northeast of Arthur's Pass village and had a 4 km long runout (Dunning, 2004).

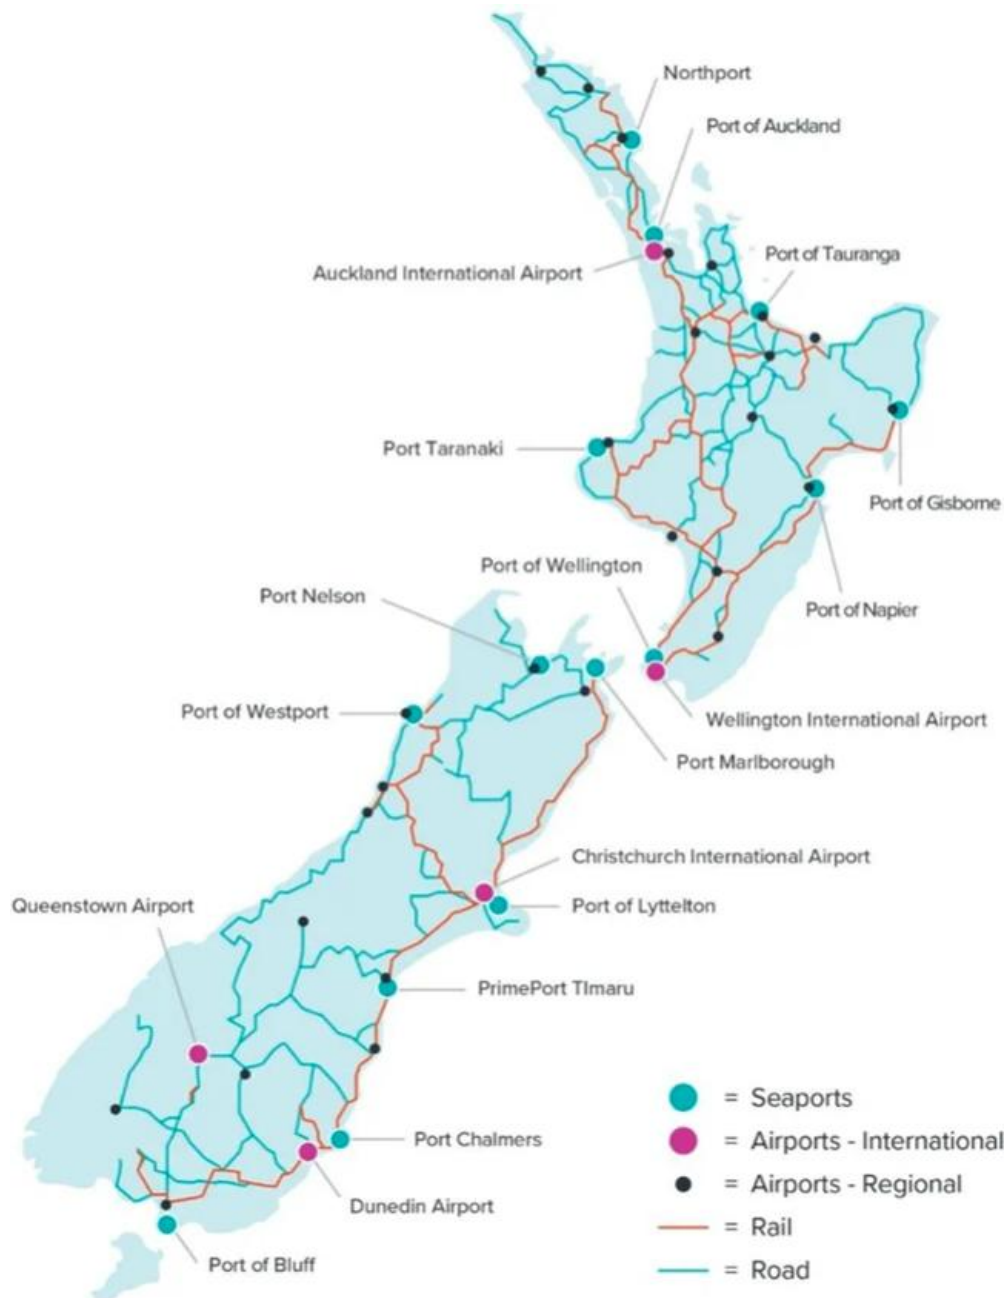
Figure 3: Critical transport infrastructure across New Zealand. The lack of redundancy in routes across the Southern Alps makes the road and rail links through Arthur's Pass critical pinch points.

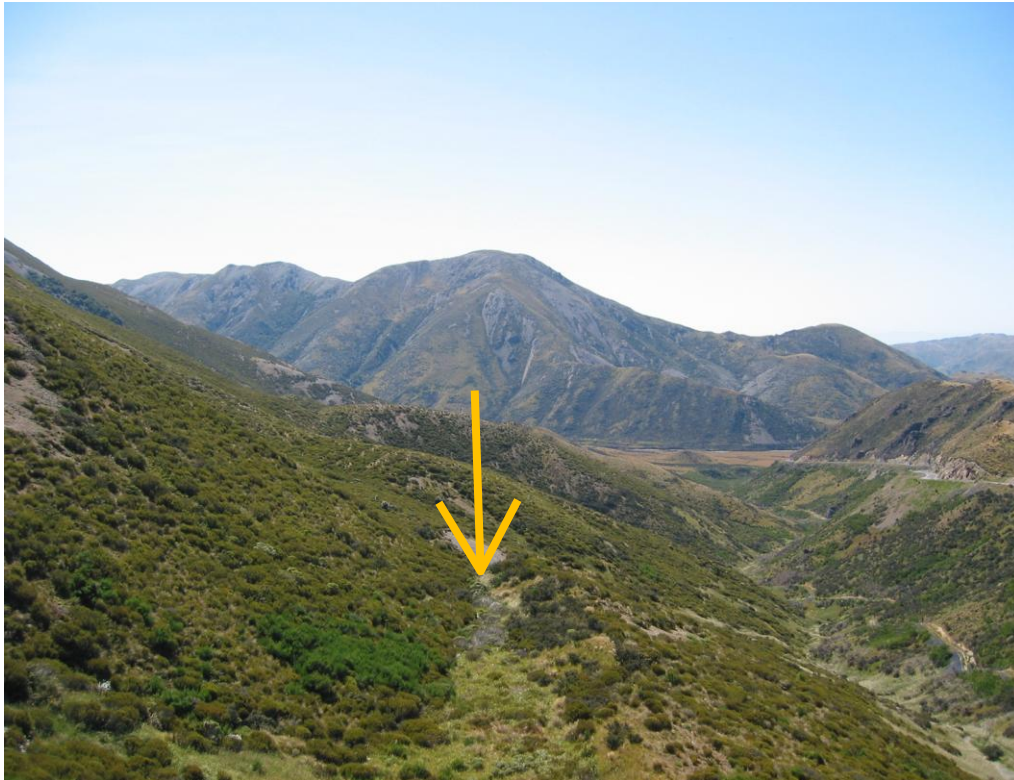
*Figure 4. Trace of the Porters Pass Fault from Porter's Pass. This fault has been trenched and its recurrence interval (c. 1500 years) and magnitude of ruptures (> M 7.0) determined (Photo: J Shulmeister).*

At Porter's Pass, we will travel alongside the trace of the Porter's Pass Fault, one of the larger active faults in the area (Figure 4). It is believed to have last ruptured about 500-600 years ago with a likely recurrence interval of about 1500 years (Howard et al., 2005). Earthquakes on this fault are significant (estimated to be  $M > 7$ ). The slip rate for the fault is estimated at 3.2-4.1 mm.yr<sup>-1</sup>. With the overall southern propagation of the plate boundary (due to oblique convergence), it is expected that the Porter's Pass Fault will become more active over time, transferring slip from the Hope Fault (currently the dominant transform fault in the Marlborough Fault system).

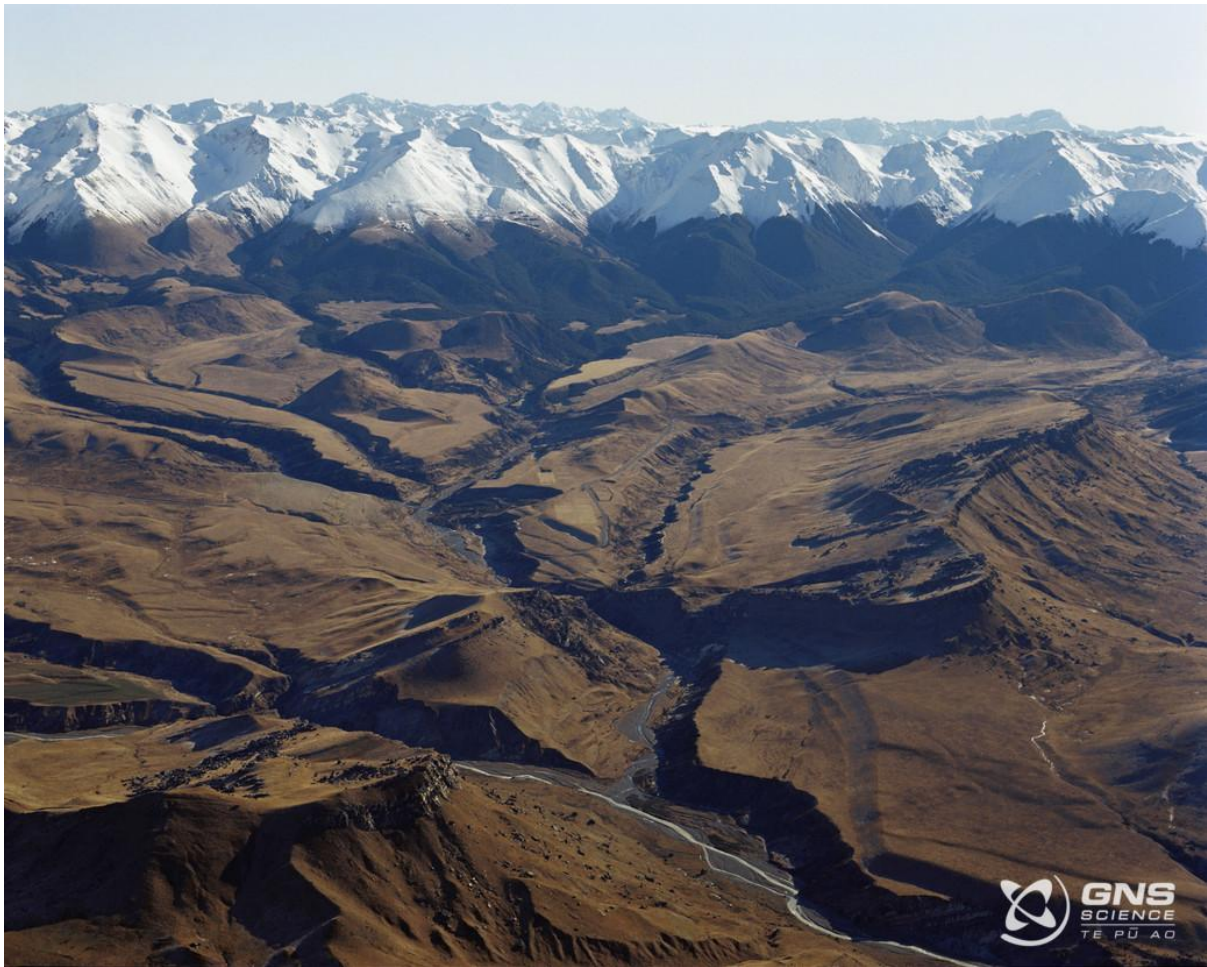
*Figure 5: Castle Hill Basin (just east of Stop 2), showing the folded and faulted sedimentary cover rocks and more recent Quaternary deposits, dissected by streams. The snow-covered Cragieburn Range creates the backdrop. State Highway 73 can be seen in the centre of the photo. Photo: D. L. Homer.*

Deformation of the rocks in the basin from faulting and folding is indicated by the visibly tilted strata, which we will gain nice views of farther along the road (Figure 5). This tilting, in combination with weathering, has created some spectacular karstic landforms in the basin area, including tors, disappearing streams, and caves. The tors in this area, likely produced from preferential subsurface weathering of joints and subsequent exhumation, are numerous and the diversity of shapes have created a popular tourist destination (Figure 6). They are also popular for bouldering (rock climbing); there is said to be more than 20,000 ‘boulder problems’ in this area making it a world-class destination for rock climbers. Closer inspection of the tors reveals a variety of karst weathering features.

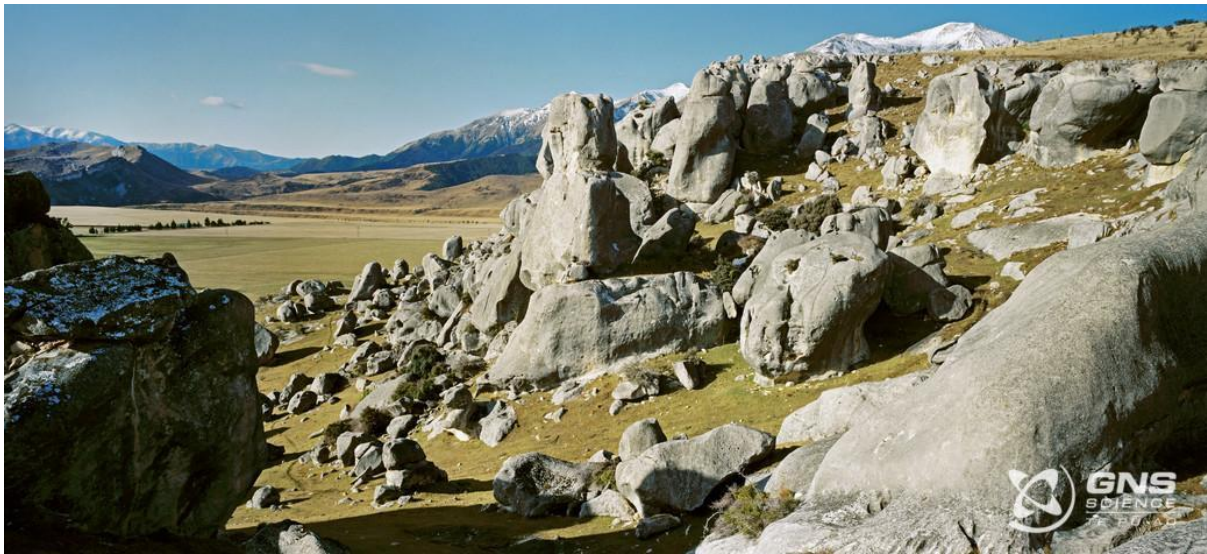
*Figure 6: Example of tors formed within the limestone rock of Castle Hill basin. Photo: D. L. Homer.*

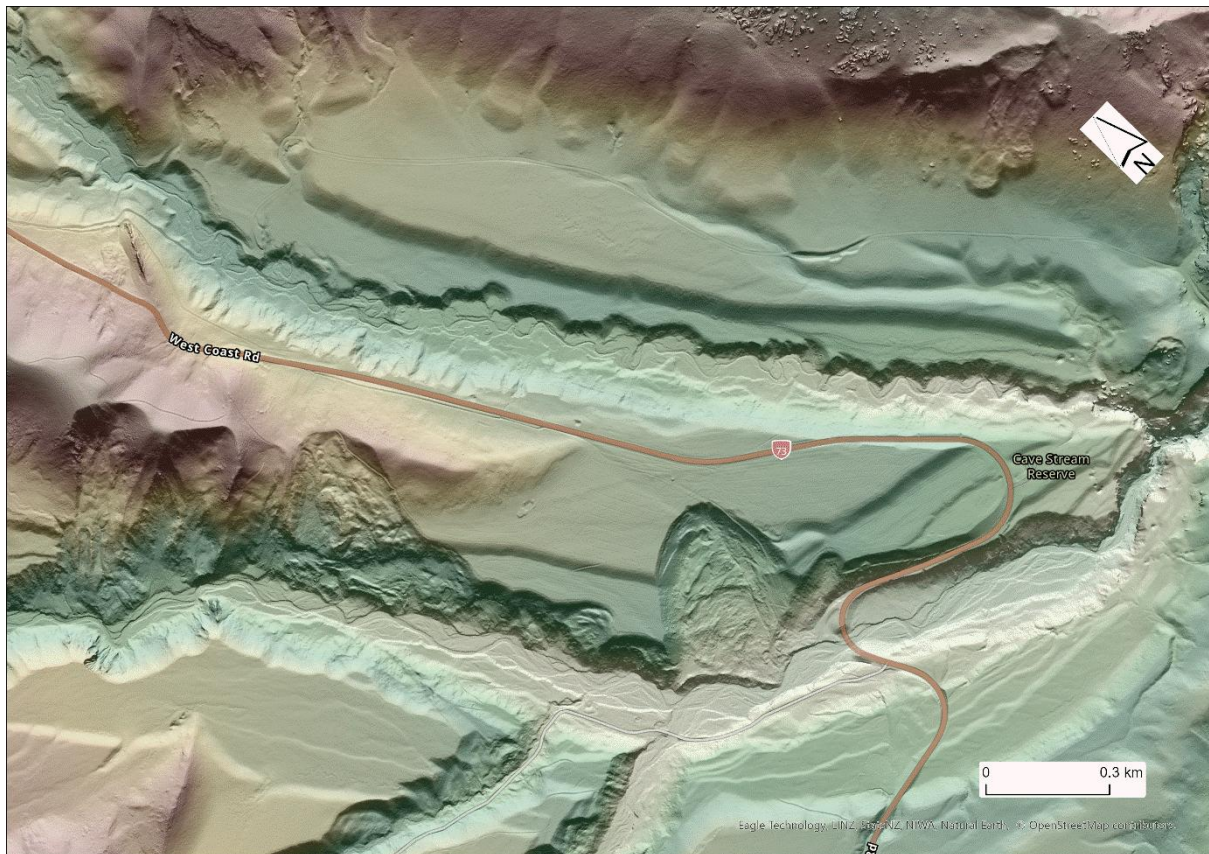
Figure 7. Examples of landslides developed within Broken River valley, along with the underfit Cave Stream in the upper part of the map. The map is produced using regional lidar from Land Information New Zealand.

Farther along SH 73, we pass several actively retrogressing landslides that have developed as a result of toe erosion, either from stream incision or quarrying (Figure 7). The initial trigger and age of initiation of these landslides is unknown, but geomorphologically, they appear to be relatively recent, and have potential to retrogress farther upslope in the future.

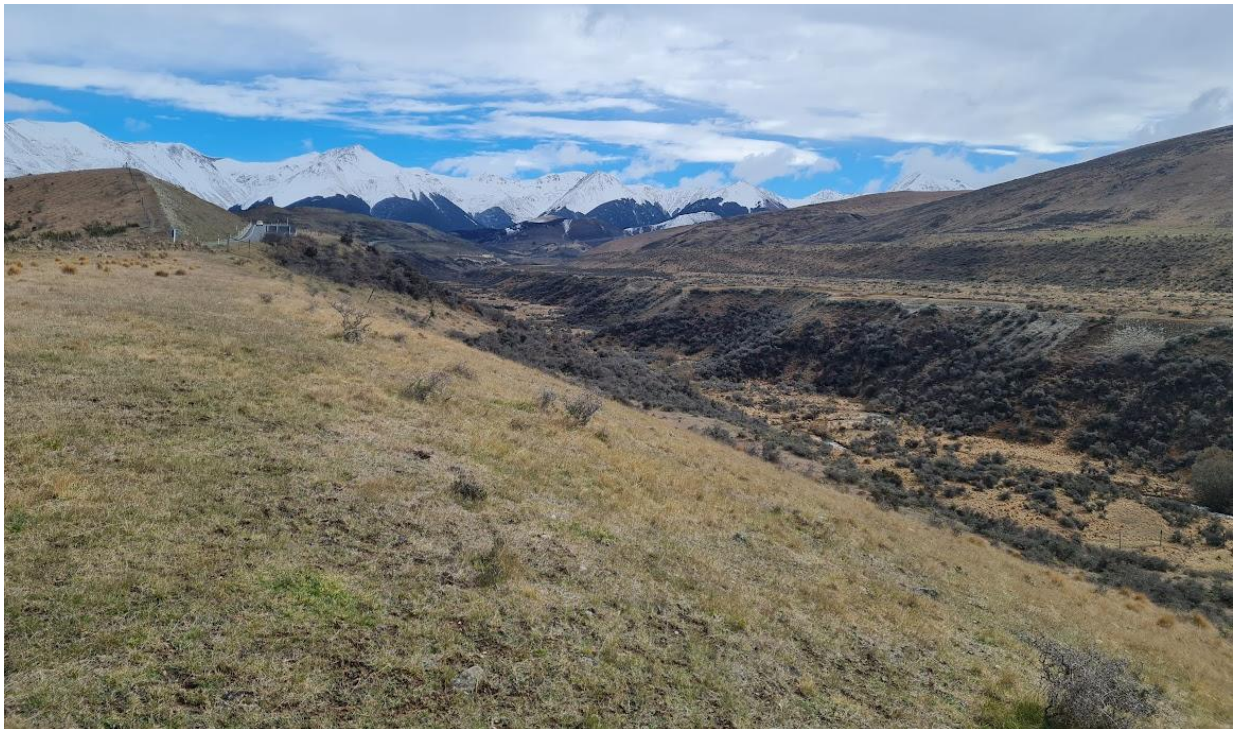
Figure 8. The terrace sequence on Cave Stream. The two higher terraces were formed when meltwater from the Waimakariri Glacier was diverted into this stream. The river now has a limited catchment in the Craigieburn Range Photo: J. Shulmeister.

Also visible, as we reach the other side of the hill approaching Cave Stream, there are an impressive series of river terraces with a distinctly underfit stream (Cave Stream) in the valley (Figure 5 and Figure 8). Karst processes have resulted in Cave Stream entering a cave, making Cave Stream Valley a blind valley. Nevertheless, the underfit nature of the stream relates neither to the tectonics nor karst processes. It is because this valley used to carry glacial melt-water from Craigieburn (River) during the peak of the last ice age. At that time, ice from the Waimakariri Glacier (specifically the Winding Creek Lobe) occupied the area of the Craigieburn Cutting (which we will travel through shortly) and diverted the Craigieburn that currently flows down the cutting, into Cave Stream. The combination of outflow from the glacier and the flow of the Craigieburn created a high aggradation terrace. There is a lower intermediate terrace, still likely related to higher flows. Even the modern valley floor suggests higher than modern flows with the cave stream meandering within its current valley.

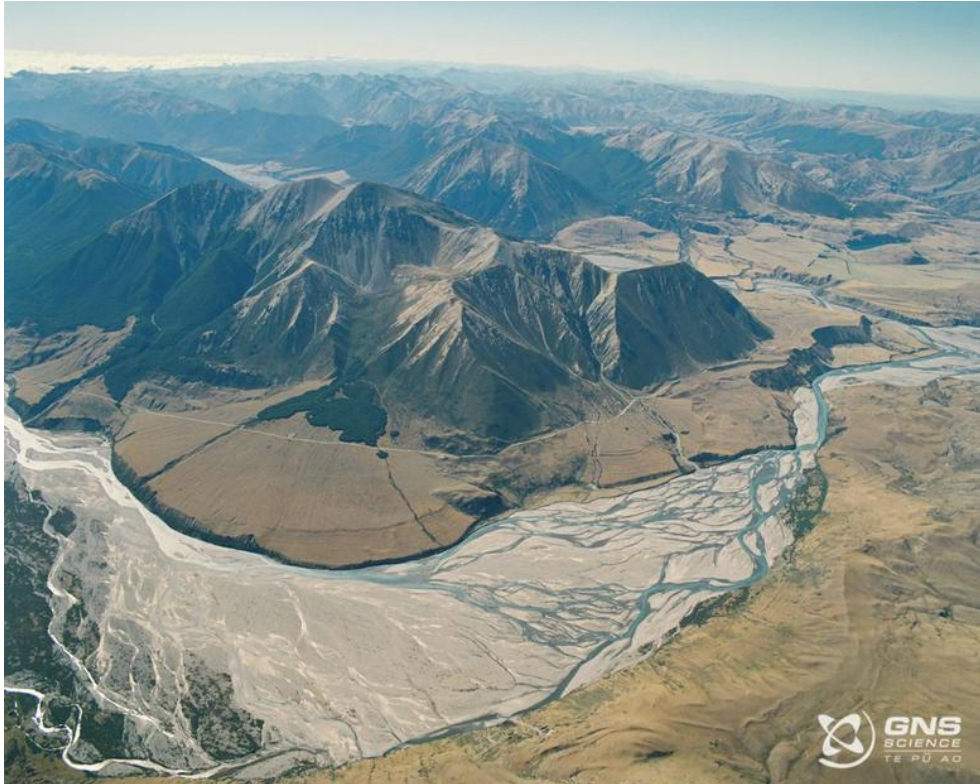
*Figure 12: Waimakariri River, looking northwards, some 18 km downstream of Stop 4. Evidence of moraine can be seen at the downstream end of the large alluvial fan. The fan is also etched by former lake shorelines, possibly related to landslide-damming of the valley. Photo: L Homer.*

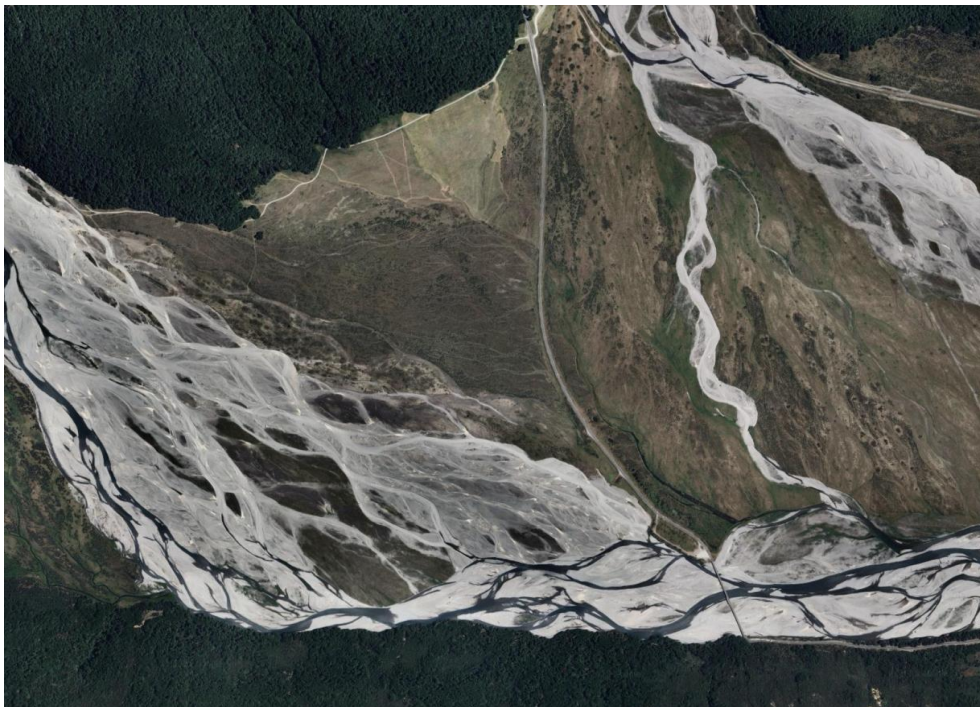
*Figure 13. Aerial view of Stop 4 at the Waimakariri River State Highway 73 Bridge. Evidence of older braided channels from the Waimakariri River to the north of its current position indicate previous positions of the river. If the river were to reoccupy these channels it would bypass the current bridge (bottom left of image) and inundate the road (centre of image) making it impassible and likely requiring either new bridge infrastructure or significant work to re-route the river back into its present position. Image: Google Earth.*

From a transport route perspective, this site presents yet another bottleneck. The bridge barely spans the narrowest section of the currently main active channel(s) of the Waimakariri, which has been forced into its current position on the true right by the Bealey River flowing from true left. Clear evidence of former Waimakariri river braids on the true left indicate older positions of the river, which if reoccupied would route the Waimakariri away from the current bridge and across the road (Figure 13). In high flow, the Waimakariri is eroding the true-left bridge abutments, where previous mitigation structures can be seen partially submerged in the channel.

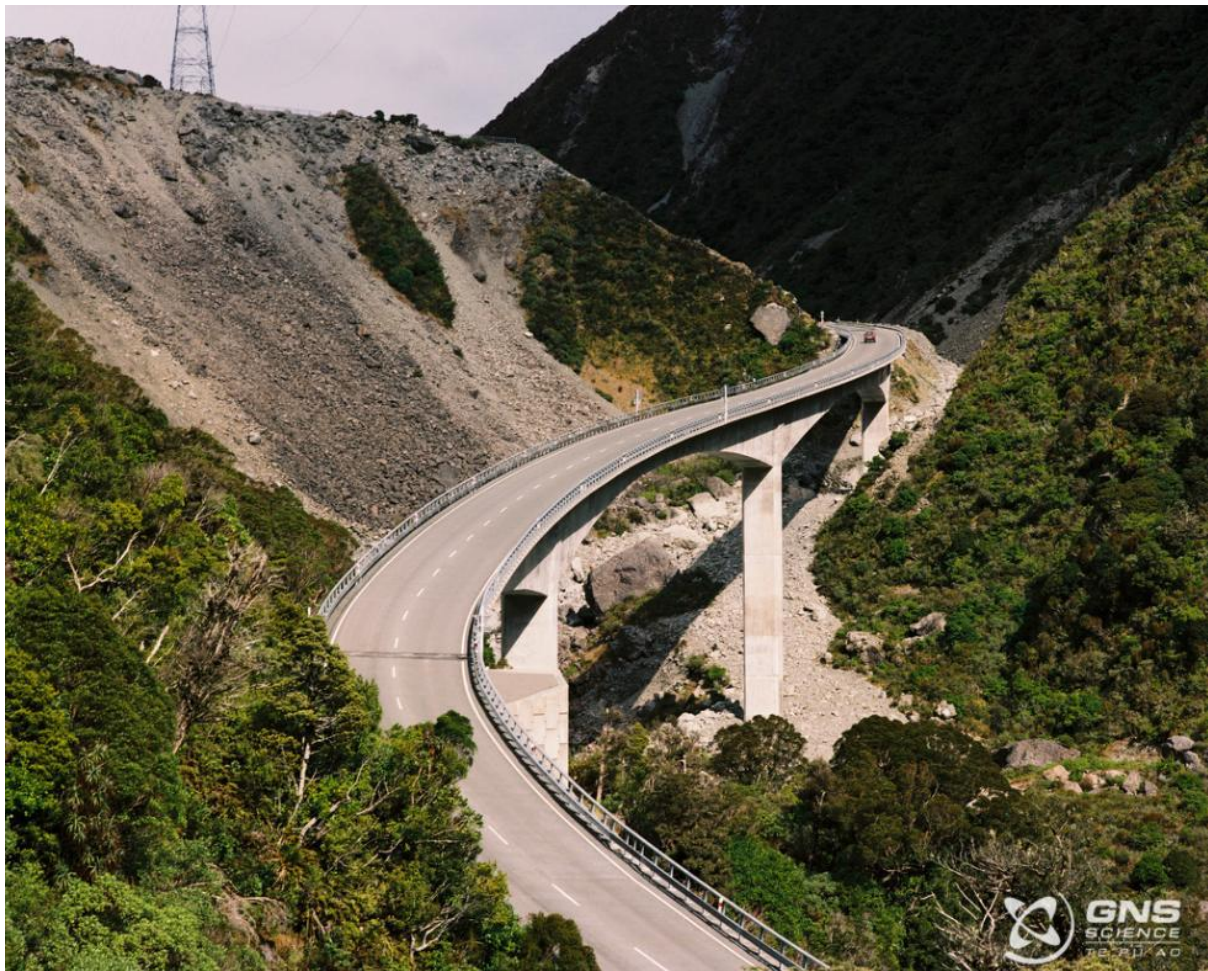
*Figure 17 – The Otira Viaduct, looking up valley. Note the large boulders in the stream bed, and the exposure on the left of the rock avalanche debris. Photo: D. L. Homer.*

Having crossed it twice today, at this final stop we will walk up to a lookout over the Otira Viaduct, a 445-metre bridge that spans a section of the Otira Gorge (Figure 17). The viaduct was built in 1999 to replace the previous road alignment that took a high route above the lookout, over the scree slopes on the true right of the river (Figure 18). The previous route had steep sections and several switch-backs, and was subject to rockfall onto the road, and washouts / collapse of the road, making it both hazardous and prone to closures and regular realignments. A notable collapse occurred in the 1929 Arthur's Pass Earthquake.

The viaduct helped to provide a longer-term solution to the problem but was faced with several challenges. This included dealing with the alpine weather and approximately 5 metres of annual rainfall in this area. There is a shallow water table with high underground flow, and artesian conditions in places. Given the risk of rockfall or smaller debris avalanches affecting the viaduct structure, the viaduct piers had to be designed to withstand impact forces, and for some piers deflection structures were constructed. Being in a very

seismically active area, the viaduct required several design features to accommodate strong earthquake shaking, including ductile piers and hinges, base isolation at the abutments, and shear keys. Completing the project within a National Park required environmentally sensitive design and construction, and consideration had to be given to avoiding damage to natural features of cultural significance to local Māori. The project has won several international awards (Billings, 2004).

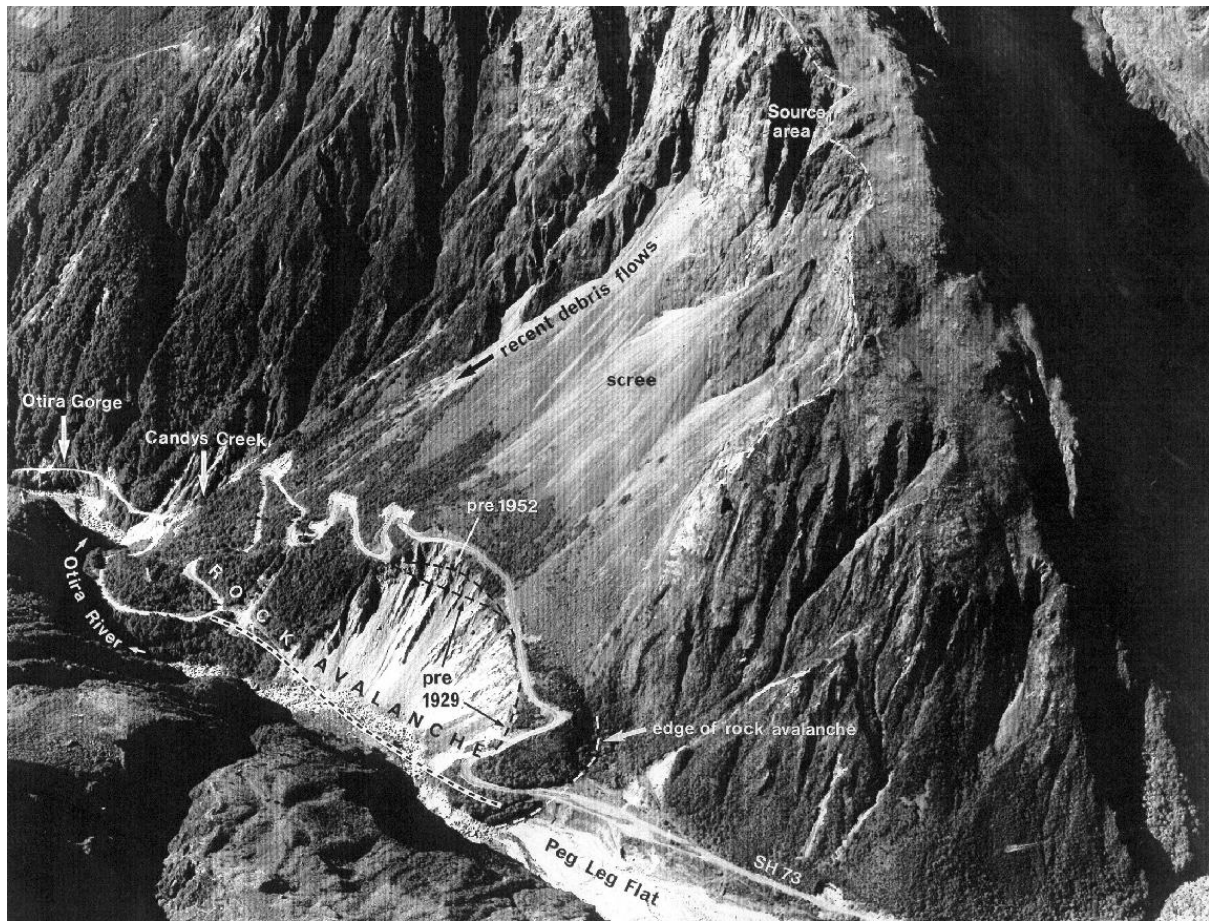
*Figure 17– View of the original road alignment, and planned alignment of the viaduct at Otira Gorge. The source area of the major rock slope failure is demarked, along with other key features. Annotated photo reproduced from Billings (2004), photo originally taken by D. L. Homer.*

The steep scree above the viaduct and the sediment upon which the previous road was aligned, originates from a large rock slope failure (Figure 18) that occurred about 2000 years ago (Whitehouse and Griffiths, 1983). The failure no doubt blocked the river at that time, but has since carved through the toe of the deposit. However, the bridge piers are embedded 25 metres fully within landslide debris, suggesting there is still some tens of metres of landslide debris lining the bottom of the valley – pilot holes were drilled to 40 metres without reaching bedrock.
