11TH IAG  
INTERNATIONAL  
CONFERENCE ON  
GEOMORPHOLOGY

# FIELDTRIP GUIDE

SEISMICALLY INDUCED LANDSCAPE EVOLUTION AND  
ENVIRONMENTAL IMPACTS IN ŌTAUTAHĪ  
CHRISTCHURCH

## **Seismically-Induced Landscape Evolution and Environmental Impacts in Ōtautahi Christchurch**

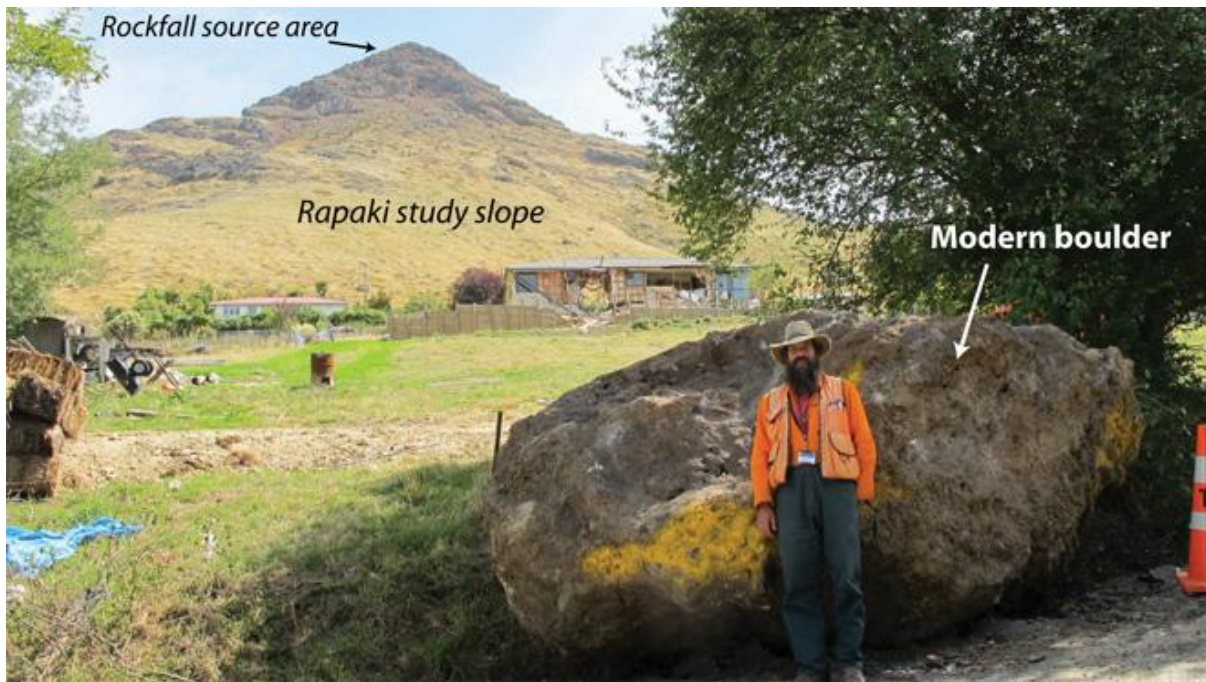
**Modern boulder at Rapaki study site.**

Photo of large modern boulder (~28 m<sup>3</sup>) detached from Mount Rapaki and emplaced in the Rapaki village during the 22 February 2011 earthquake (photo courtesy of D. J. A. Barrell, GNS Science). The boulder traveled through the center of the residential home located in background (center). Boulder runout distance from source was ~700 m. Runout distance for furthest traveled modern boulders is significantly greater (~150 to 175 m) than travel distance for prehistoric boulders.

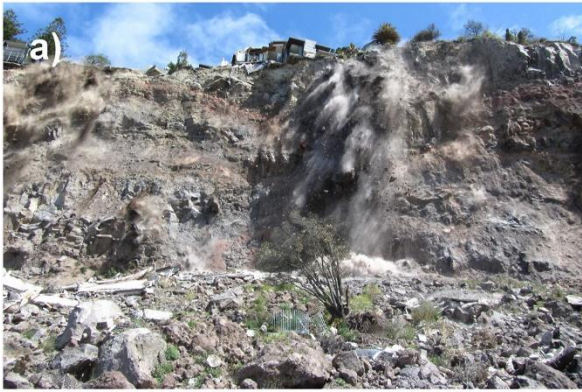
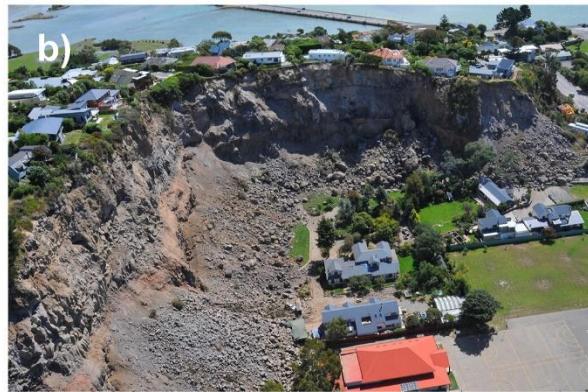
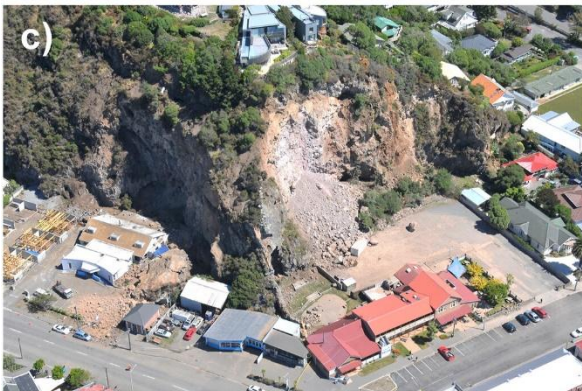
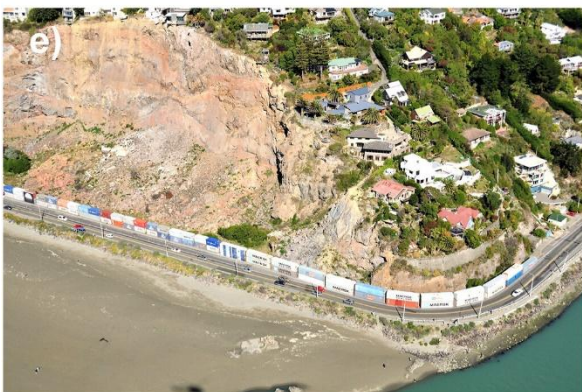
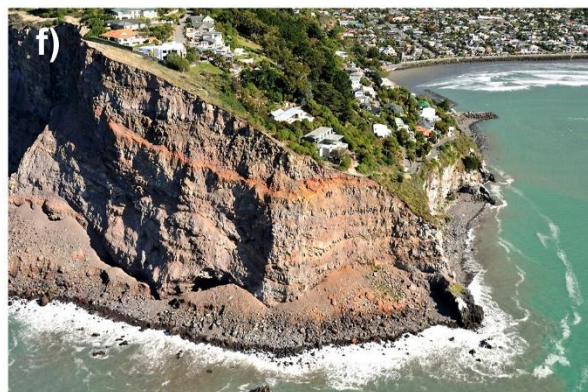
*Photographs showing the major slopes in this study. (a) Shag Rock Reserve (Peacock's Gallup), taken during the 14 February 2016, earthquake (Photo Credit: Stuff). (b) Redcliffs taken after the 22 February 2011 earthquake (Photo Credit: G.T. Hancox). (c) Wakefield and Nayland, taken after the 22 February 2011 earthquake (Photo Credit: G.T. Hancox). (d) Redcliffs Road, taken after the 13 June 2011 earthquake. (e) Shag Rock Reserve, taken after the 13 June 2011 earthquake. (f) Whitewash Head, taken after 13 June 2011 earthquake.*

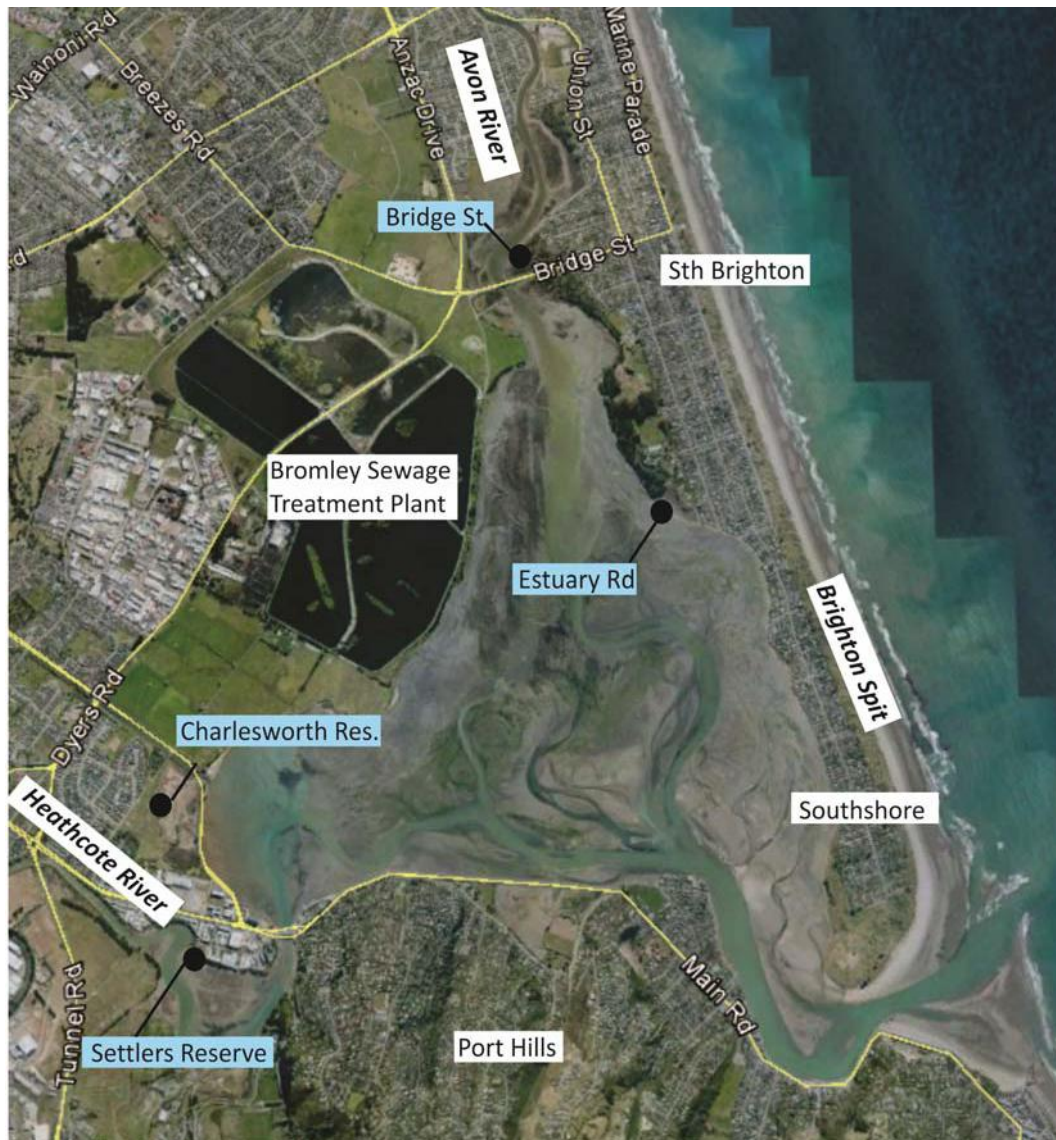
*Geographic features of the Avon-Heathcote/Ihutai Estuary and the survey sites used to assess deformation and biotic response to coseismic deformation by Reid, Cochran, Clark and Marsden.*

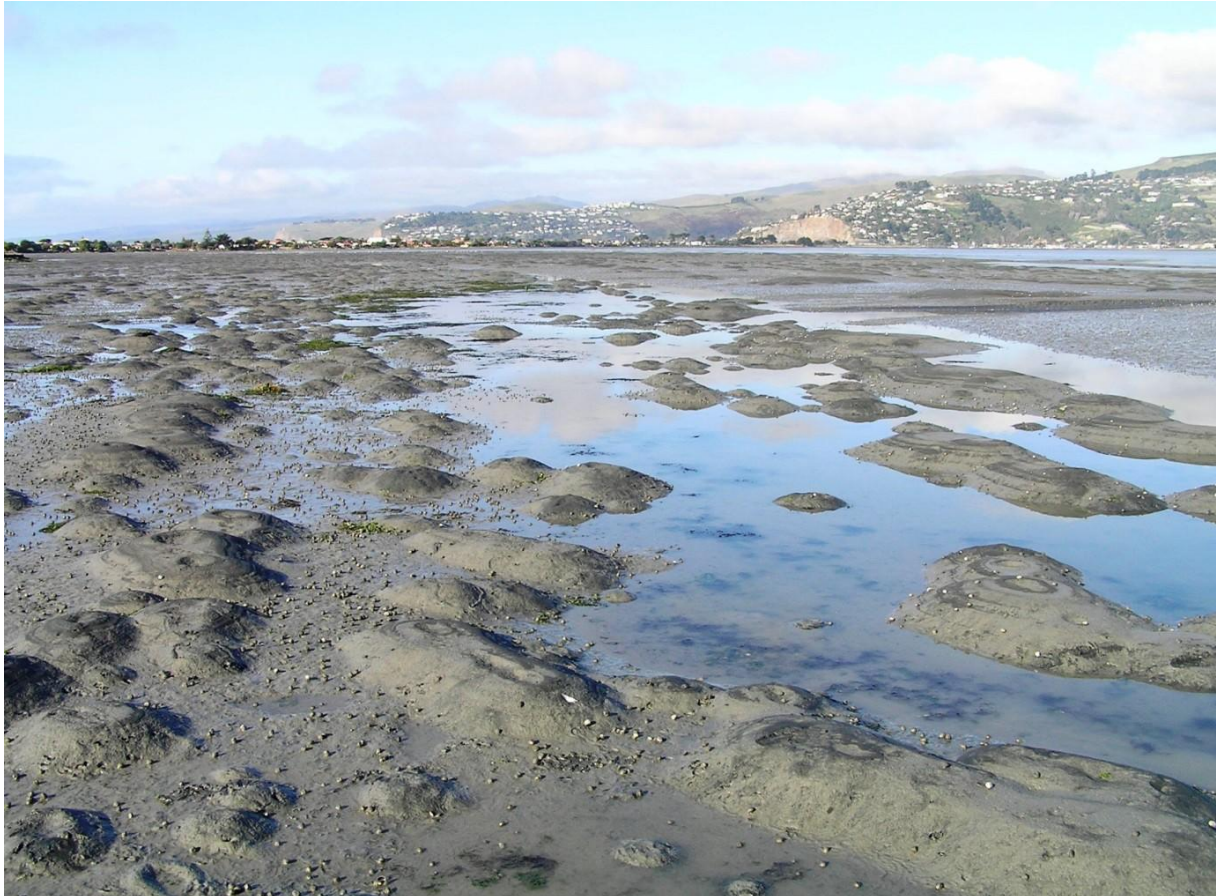
*Sand volcanoes in the Estuary Rd area produced by the 13<sup>th</sup> June 2011 aftershocks prior to removal by wave and tide action.*

The September 2010 mainshock and each of the major aftershocks resulted in widespread development of sand volcanoes in the AHE (Fig. 10 and 11) and these were most pronounced following the February 2011 event (Reid et al. 2012). The record of these sand blows is now largely removed by tidal and wave activity, although remnants of the larger cones remain in sheltered areas (these can be seen at Bridge St). The sand introduced to the Estuary has largely been reworked rather than removed and the floor of the middle AHE has been raised both by tectonic deformation and the retention of fine sand introduced following liquefaction (Measures et al 2011). In places broad low sand bars remain where following the February and June events large (7-8m diameter) sand blows were seen. Elsewhere sand introduced by liquefaction can be seen as a redistributed veneer over mud or sandy mud pre-CES surfaces.

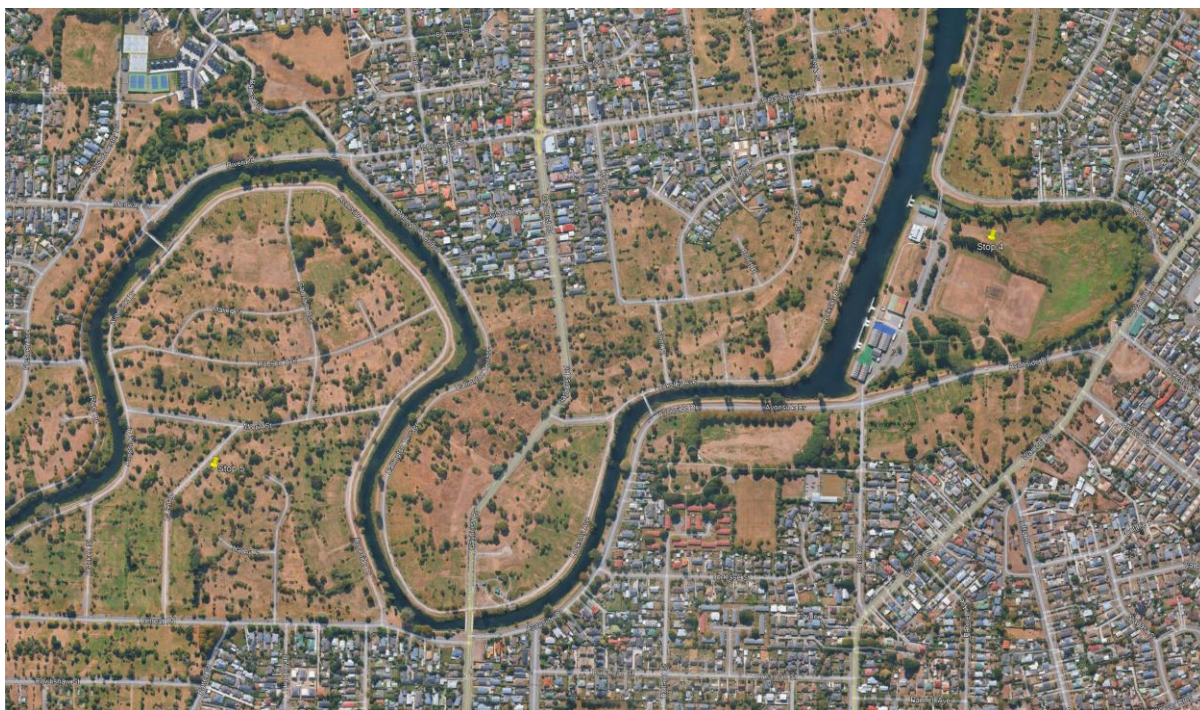
## **STOP 4: AVONSIDE: Liquefaction at Porritt Park** **(Bastin and Duffy leads)**

At this stop, we will consider the importance of buried geomorphology and will also pay some attention to the effects of anthropogenic activity on liquefaction effects. The area is located adjacent to the Avon River, with Porritt Park comprising an anthropogenically cut-off meander bend. Porritt Park and the wider Avondale area generally experienced severe liquefaction during the CES. Twith lateral spreading additionally occurring towards the Avon River.

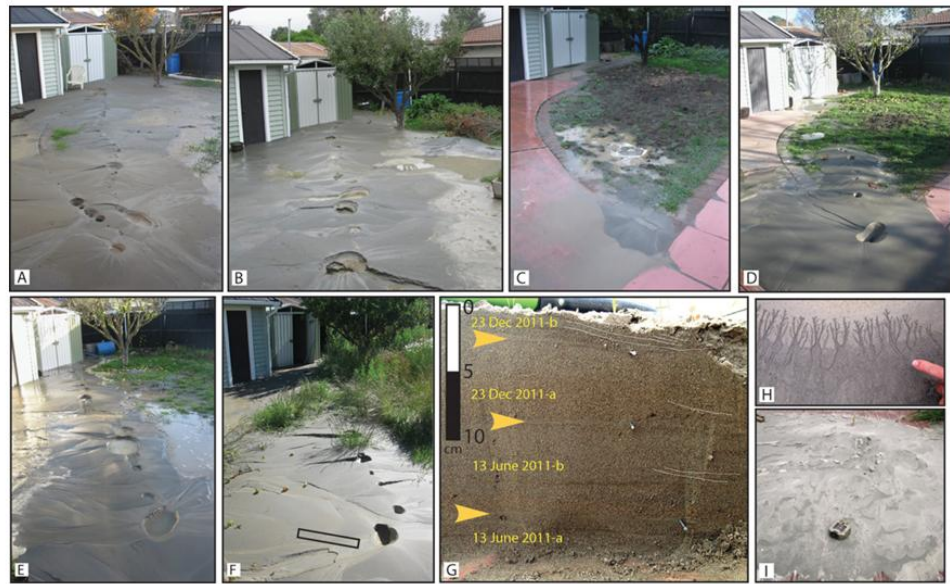
Figure 2. A–F: Field photographs (looking south-west) of sand blows at study site following the (A) Darfield  $M_L$  7.1 earthquake, (B) 22 February 2011  $M_L$  6.3, 5.8, and 5.9 earthquakes, (C) 16 April 2011  $M_L$  5.5 earthquake, (D) 13 June 2011-a  $M_L$  5.6 earthquake, (E) 13 June 2011-b  $M_L$  6.4 earthquake, and (F) 23 December 2011  $M_L$  5.8 and 6.0 earthquakes. All photos were taken from same location within 3 h of last inducing earthquake. G: Distinct liquefaction ejecta units in sand blow stratigraphy. Arrows and nails denote silt drapes. Cross-bedding as sketched. Location of photographed portion of trench location shown in F. H: Microrill development in silt drape at edge of a sand blow. I: Post-depositional erosion of sand blow and silt drape to form parabolic microdunes and ripples only 2 mo after formation.
